Snyder v. Bass Pro Outdoor World, LLC. Engineering Investigation

George M. Saunders, Jr., P.E., C.F.E.I.
Mechanical Engineer

Project No.: S15-016

June 7, 2017

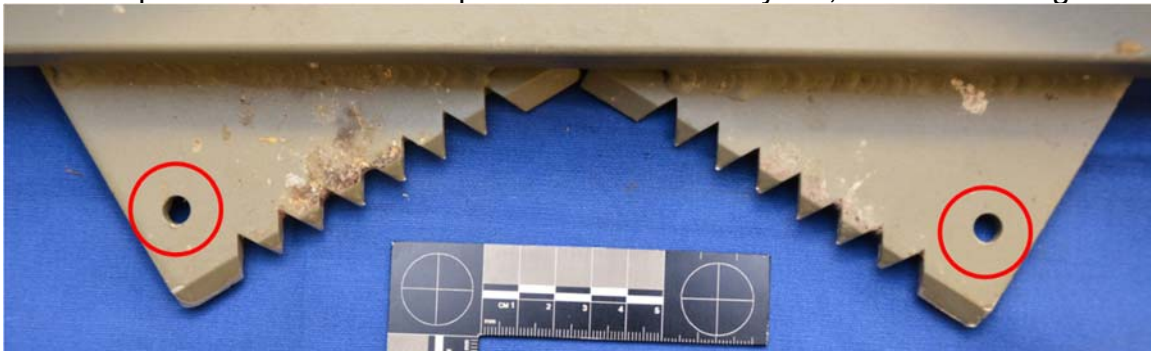
- The climbing instructions illustrate the user being connected to the tree with a full body harness fall arrest system prior to stepping on the to the treestand at ground level, Step A and Figure G. (page 8).
- Step E and Figure L of the climbing instructions instructs the user to secure the seat frame of the treestand to the tree to the tree with the provided stabilizer strap via the holes in the yoke, illustrated in Figure 3.

Figure 3 – Photograph 33 - Cropped and annotated

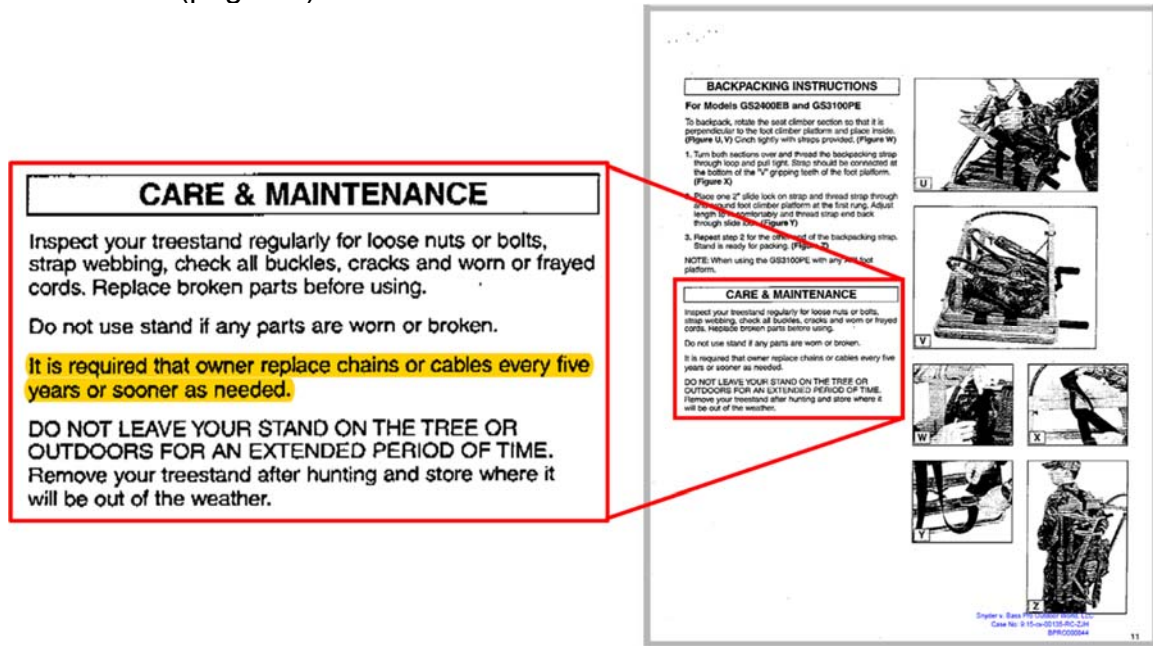
Figure 4 - Page 11 - Care & Maintenance

- The 'climbing down' section of the instructions instructs the user not to "REMOVE THE SAFETY HARNESS TETHER FROM THE TREE UNTIL YOU HAVE REACHED GROUND LEVEL." (page 9).
- Under the heading Care & Maintenance the user was instructed to replace the chain every five years at a maximum, as illustrated in Figure 4. (page 11).

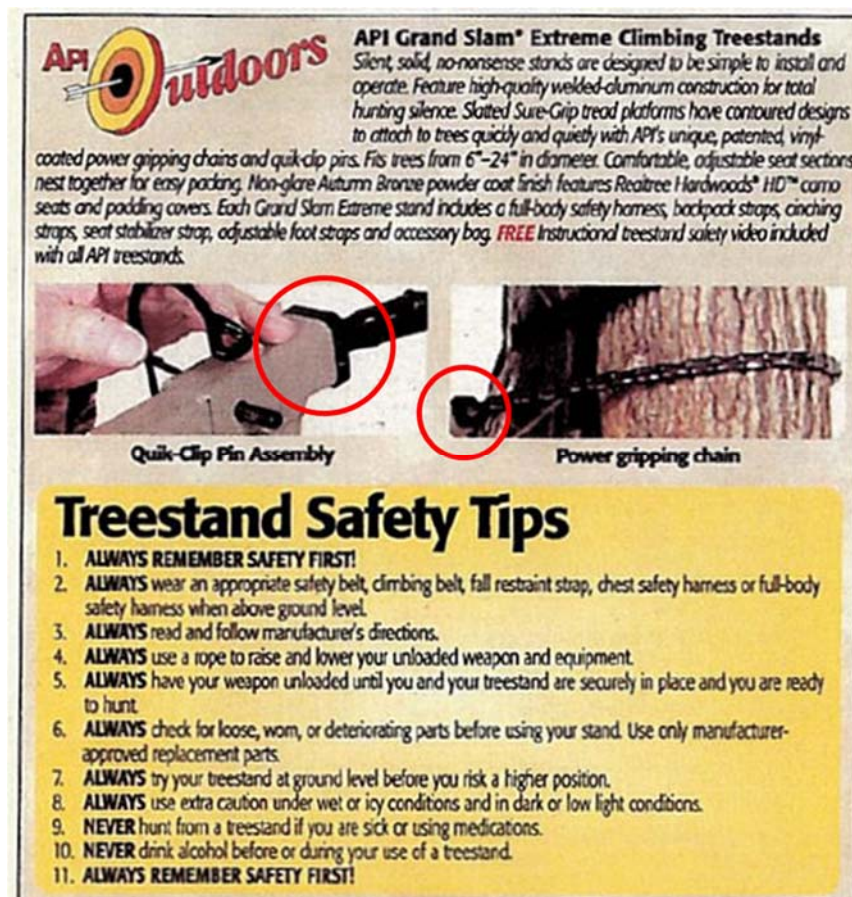
Figure 8 - Crop from BPRO 000904 (2003 Hunting Catalog)

On-product labeling, illustrated in Photographs 155 through 170, indicate that the incident treestand was manufactured under the API Brand by Outland Sports, Inc. in Tallulah, Louisiana. Based on an inspection of the product and a review of the catalogs produced in the matter, the treestand involved in Mr. Snyder incident appears to be a Grand Slam Extreme model from the 2003 model year (BPRO000896). This determination was made based on the overall configuration of the product, the camouflage pattern utilized for the seat and padding covers, the number of connection points for the sling seat, and the information regarding the timeframe for Outland Sports to have been the manufacturer of API brand treestands. Also from the 2003 catalogs the Grand Slam Extreme treestands came equipped with polymer chain guides, based on BPRP 000904 illustrated in Figure 8.
